PHSEN Tech Refresh & Quality Assessment

OOI MIO Instrument & Data Teams

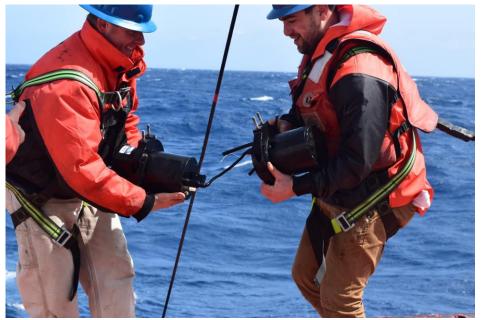
GS01SUMO-00004

- Ease of Use
 - Manual flushing required before deployment to prevent air-locking
- Vendor Quality
 - Issues with incorrect wiring for inductive units
 - No controlled schematics/drawings, units not consistently manufactured to a spec
 - Buggy software
- Safety
 - Leak issues results in seawater-battery interactions and over-pressurization
 - Root cause not definitively determined likely leaking around fiber entry
 - Vent plug added to housing to allow for venting on recovery
- Reliability
 - Issues with batteries discharging quicker than anticipated
 - Housing not sufficiently robust for SUMO mooring riser deployments

PHSEN Instrument Issues
